PLD-PZ005-V1.9 [0, 0]

## Board markings

PLD-PZ005-V1.9.

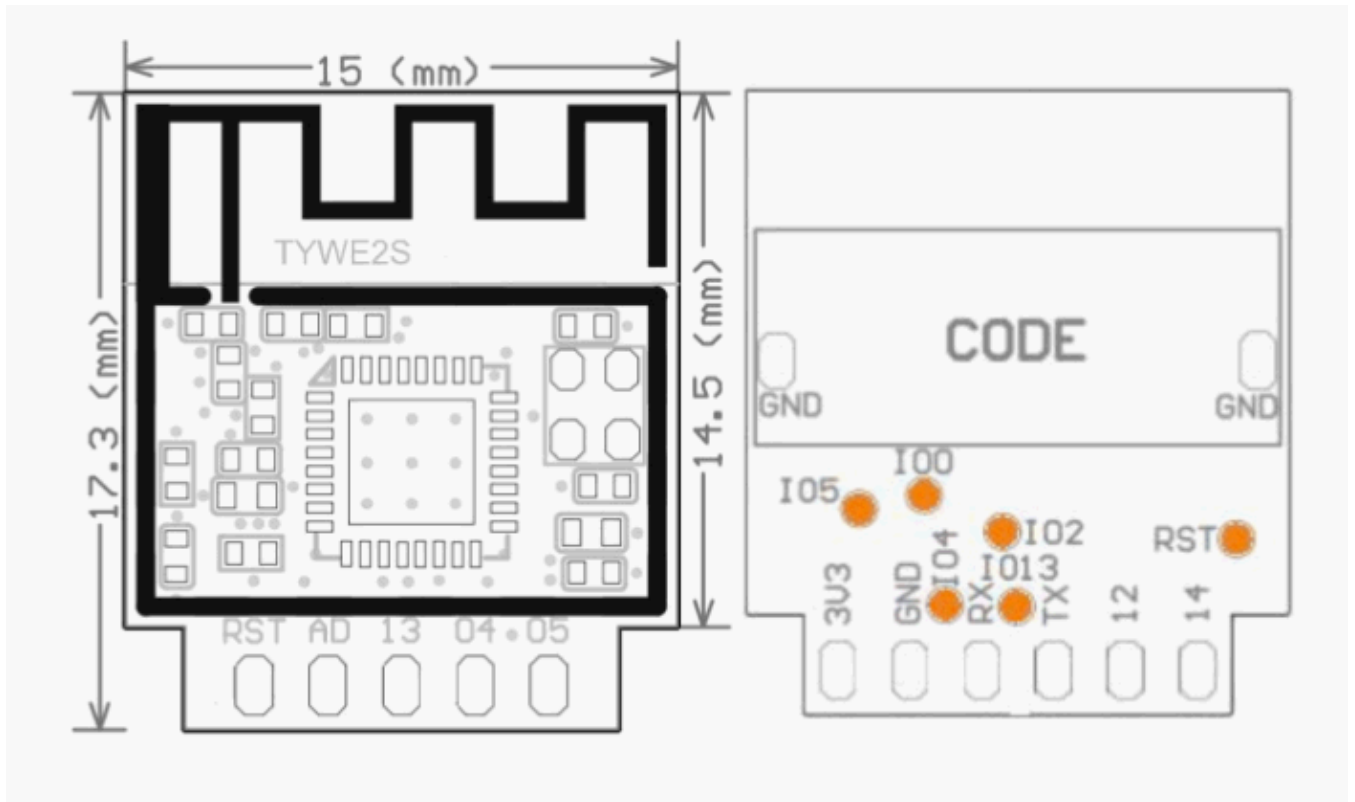
TYWE2S

pins on flat side (bottom)

3v3  
 gnd  
 rx  
 tx  
 12  
 14

pins on side with components

rst  
 ad  
 13  
 04  
 05
